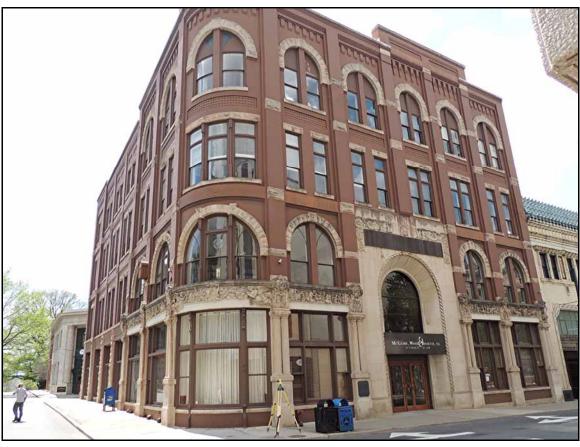
Note the brick work and how the stone on the tops of the windows is set.

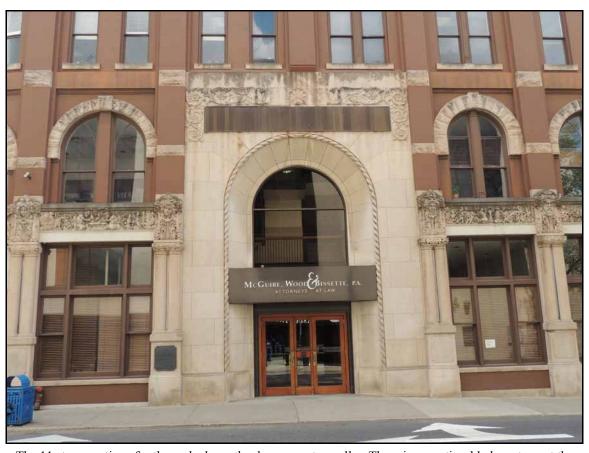
The 11 stone sections for the arch above the door are set equally. There is no noticeable key stone at the center of the arch. The carvings in the stone are beautiful. Note the mild staining at the top of the stone and the heavier staining on the carvings.

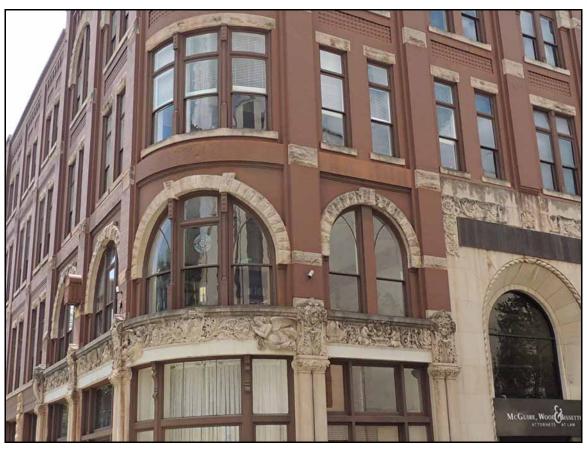
Note how the staining on the stone starts at the top and works its way down.

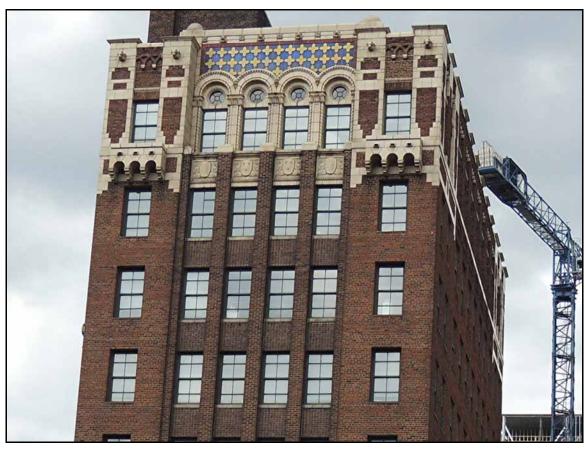
Note the darker brick, which appears to be staining, in the center area of the building.

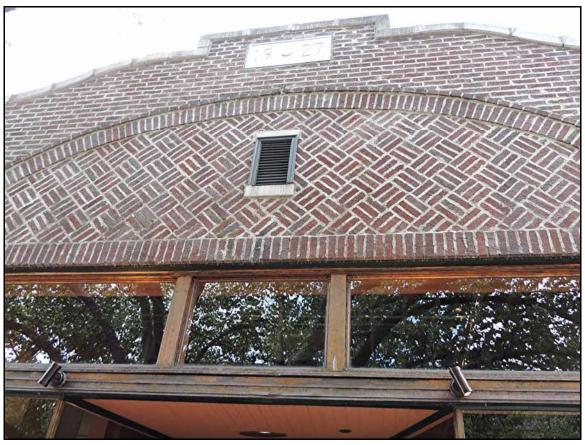
Note the spacing between the bricks on this building front and the increased amounts of mortar used to set them.

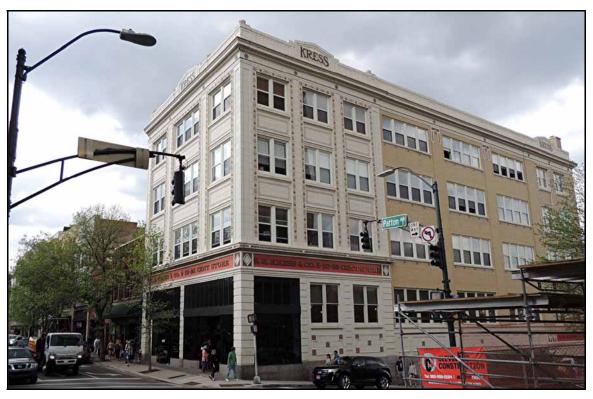
The yellow brick area of this building was added at a later date and while the builders tried to match the stone top they got close, but it is slightly off.

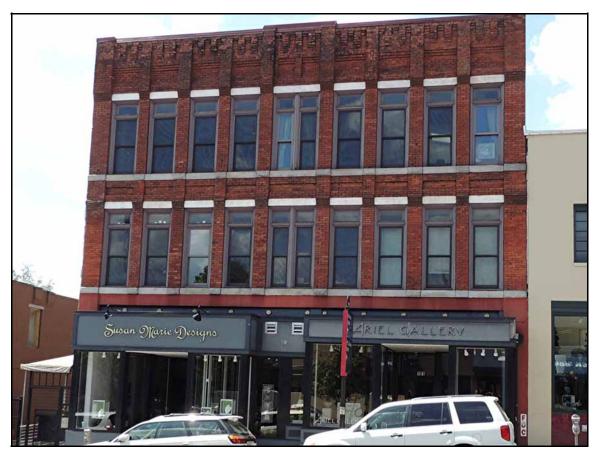
The brick work at the upper area of this building is extensive, however much of it is hard to see at first glance due to the staining.

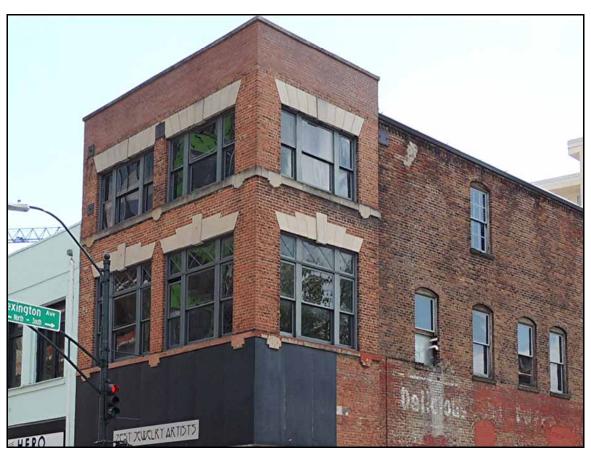
The brick color and lack of stone work above the windows indicates that the back half of the building was added at a later date.

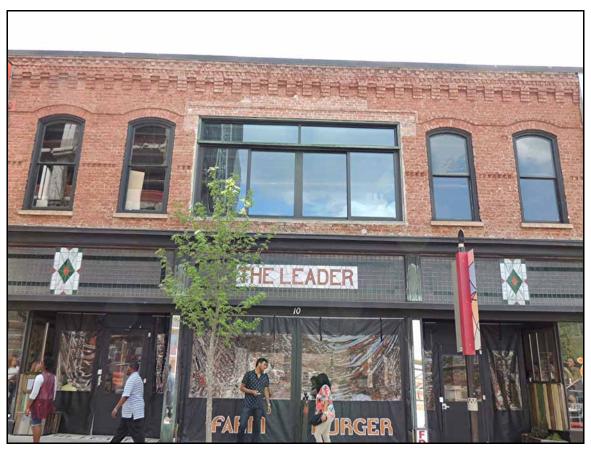
This building front has some nice brick work that has been pressure washed. Note the repair work done above the large window.

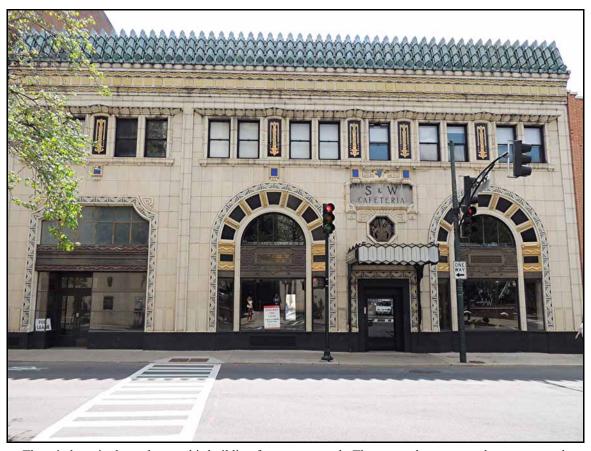
The windows in the arches on this building face are unusual. There must be some steel structure work inside the building to support the stone and not place any weight on the glass.

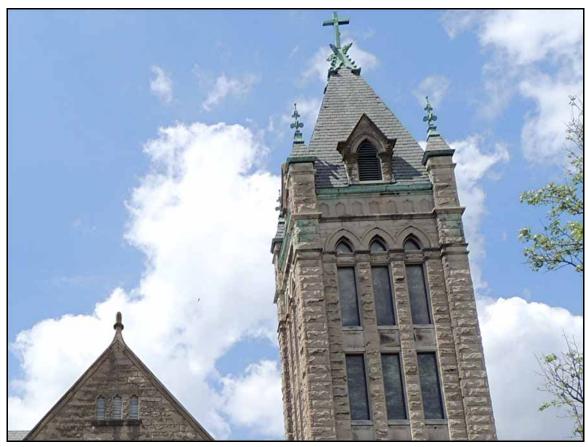
Note the green staining on the stone bleeding off the copper. The green color is almost identical to the tarnishing of the copper at the Biltmore house.
