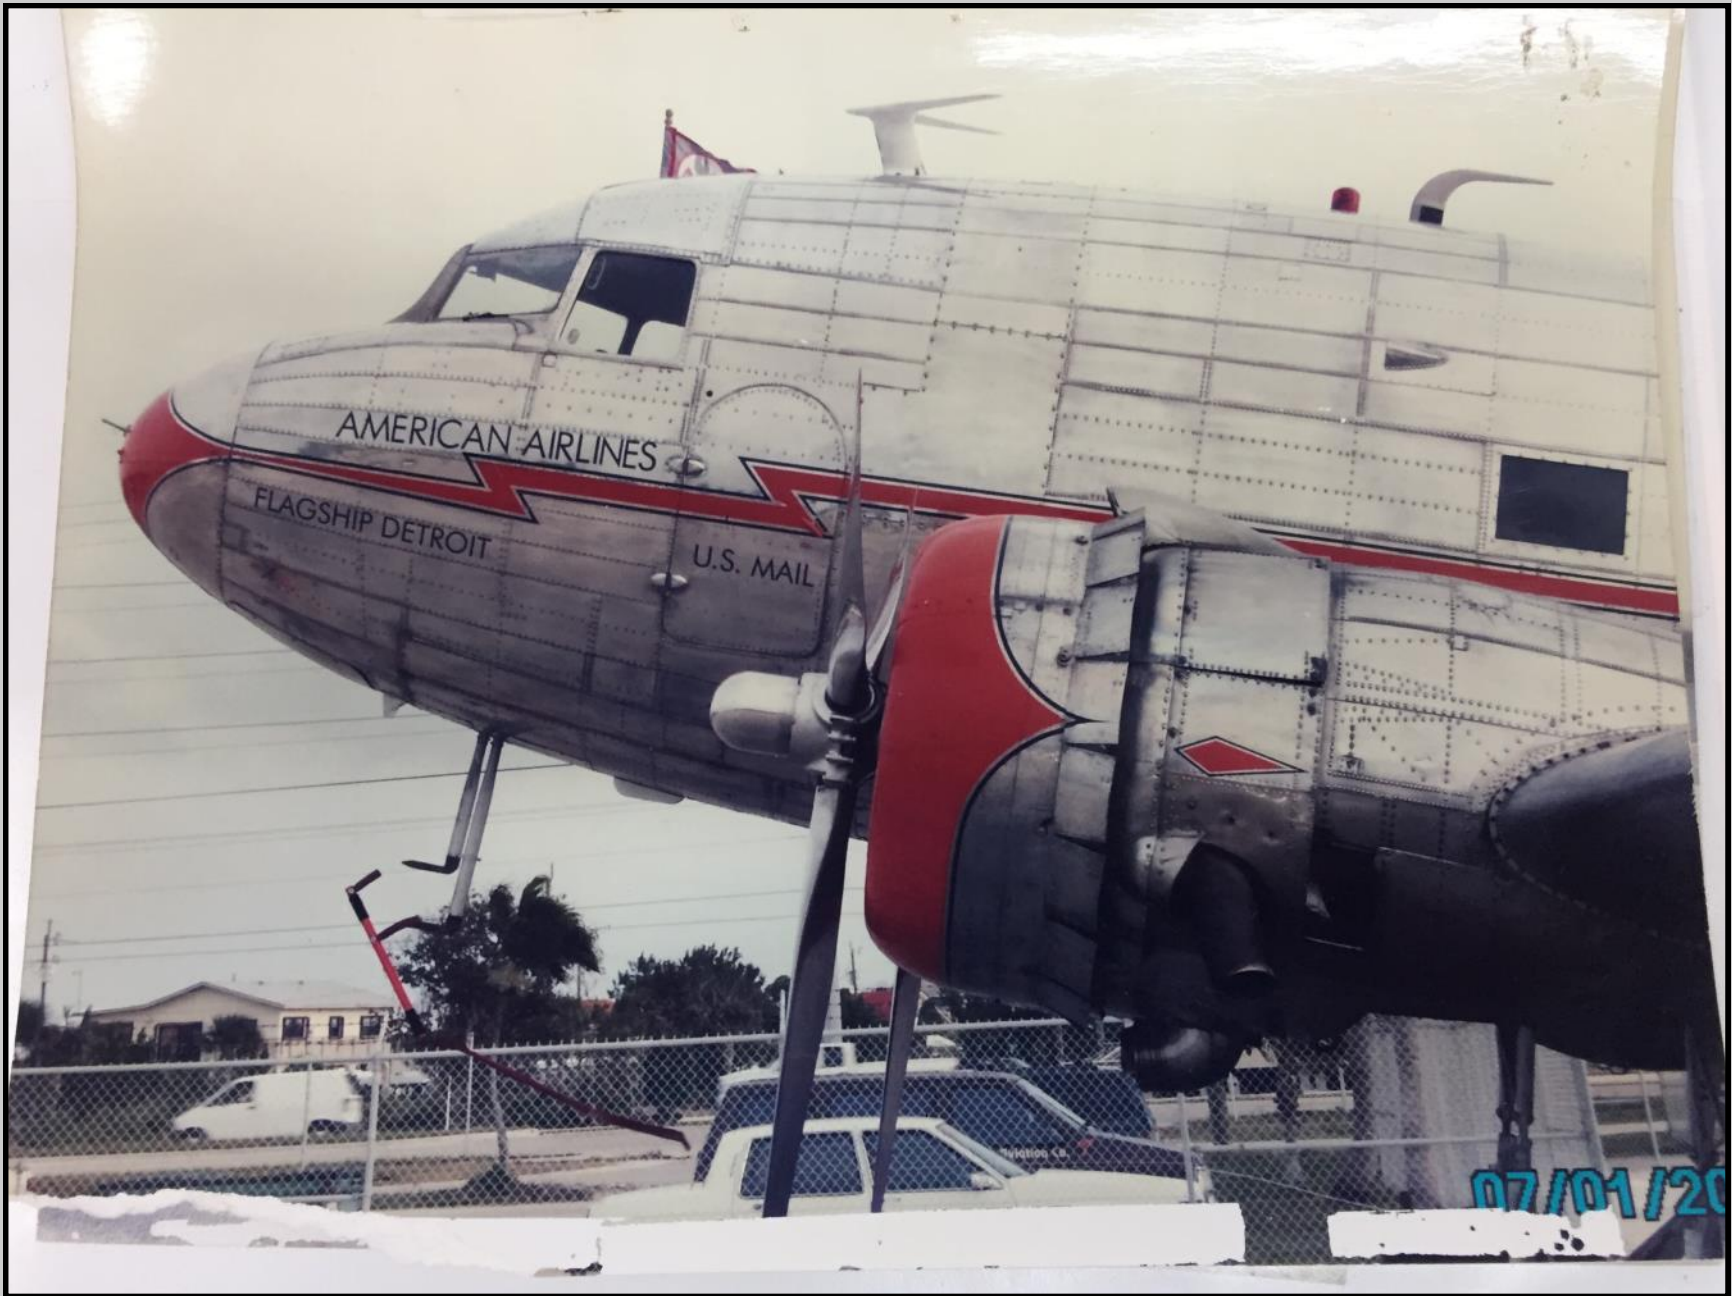
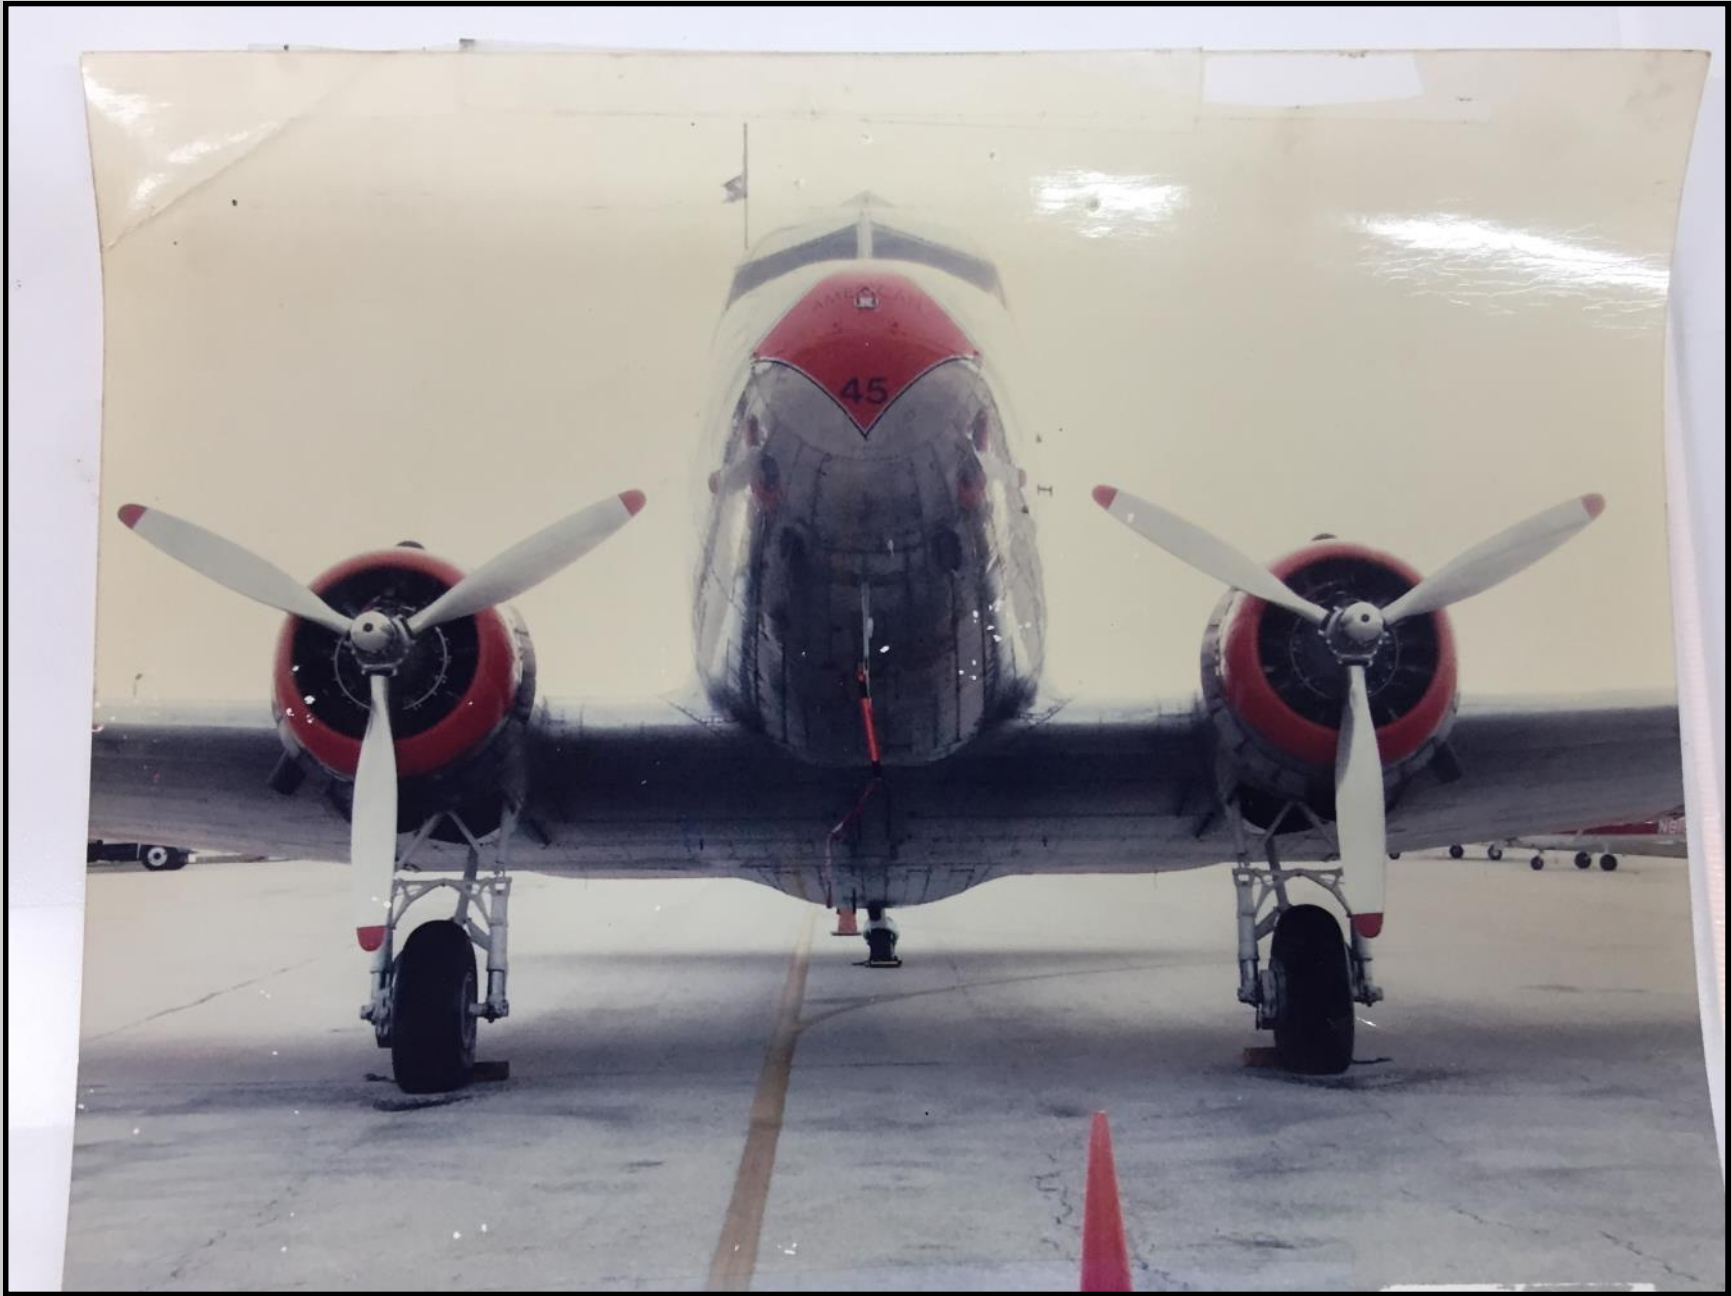
These two pictures were found in a dusty binder at the Marathon, Florida airport air museum, which is located in the Florida Keys. What is interesting about these two pictures is the weathered appearance of this natural aluminum DC-3 aircraft. Most of the surface is lap jointed with raised rivets and the edges of the lap joints and the rivets are all covered with soot.
